# Contactless outdoor PL of silicon PV modules with large area excitation source

Bernd Doll, Johannes Hepp, Mathis Hoffmann, Oleksandr Stroyuk, Andreas Vetter, Marc Hemsendorf, Dirk Tegtmeier, Florian Talkenberg, Michael Menz, Manuel Baier, René Schüler, Larry Lüer, Christian Camus, Claudia Buerhop, Jens Hauch, I. Marius Peters, Christoph J. Brabec

**EU PVSEC 2020 - 5DO.3.3**  
**10.09.2020**

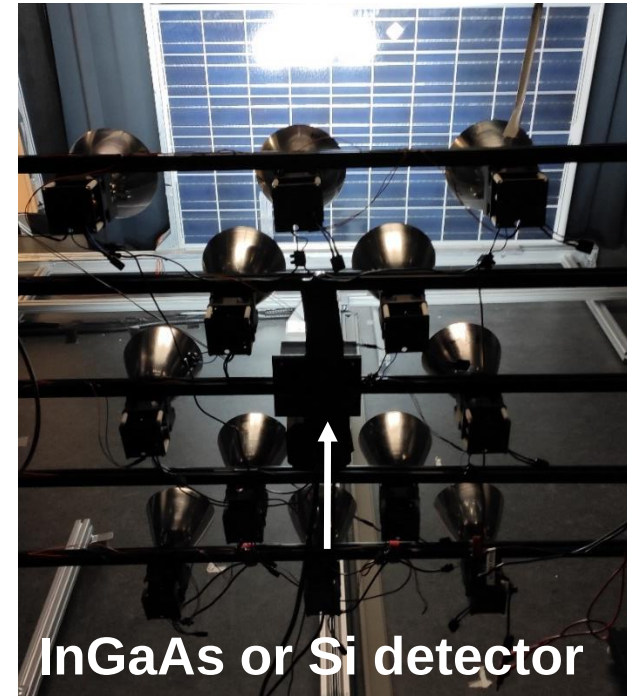
# PL setup in the lab

- EL and PL images with  $t_{\text{int}} = 15 \text{ s}$
- 12x 100 W broadband white LEDs

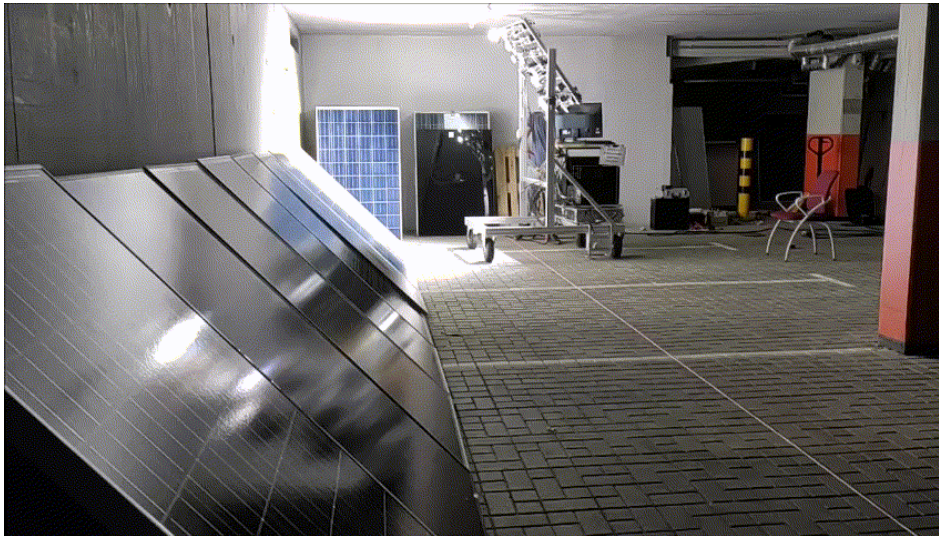
- Setup at work

# PL setup suitable for outdoor use
